Mobile RV Tech Services

# Service Report

This report is for completing the following list of repairs:

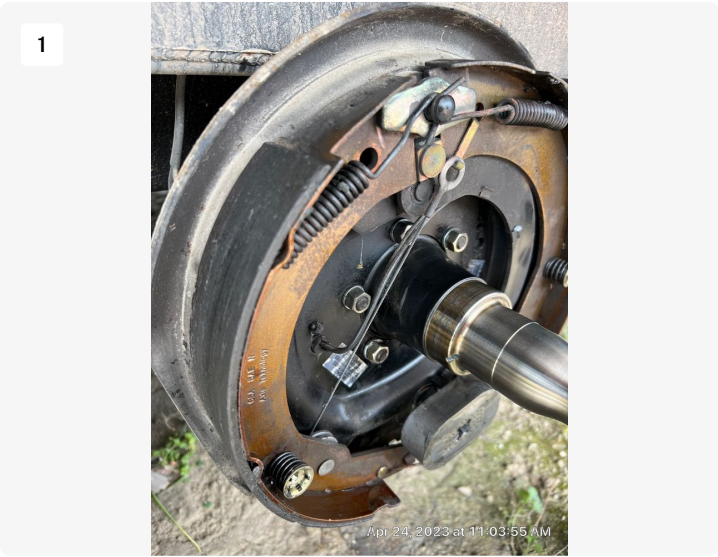
Axle spindle and brake assemblies were cleaned and inspected.

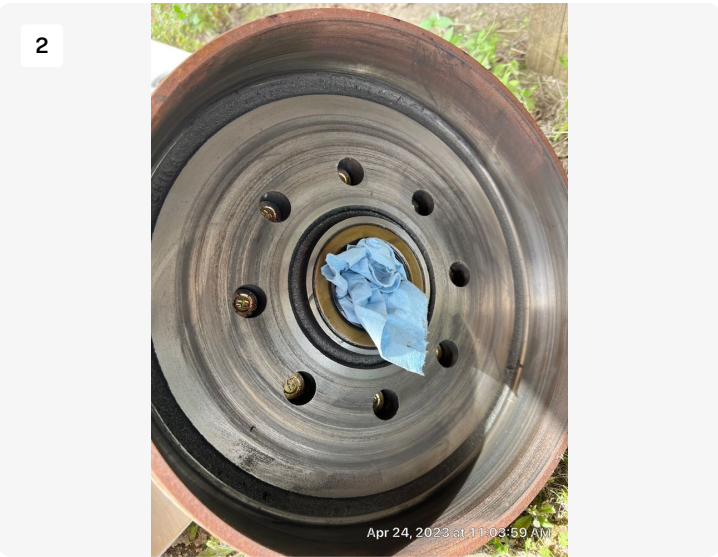
Hubs and brakes were cleaned and inspected.

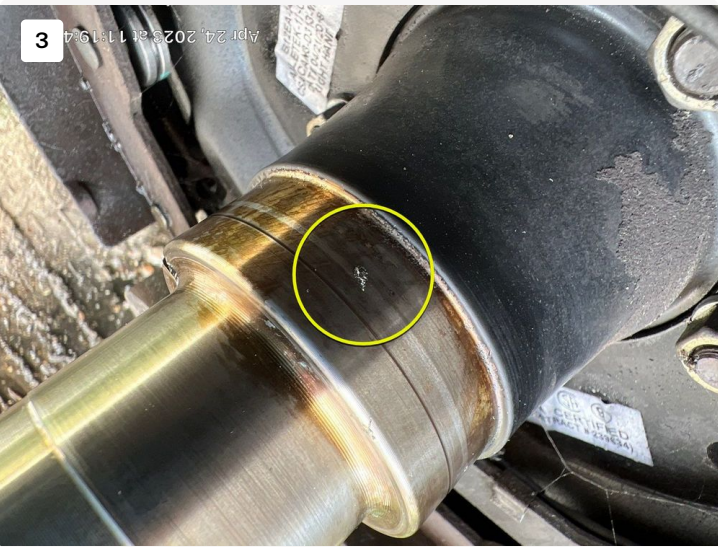
The curbside rear spindle had a burr where the seal spins and it tore the seal.

The spindle was sanded with fine emory cloth to remove the burr. A new seal was installed on this assembly.

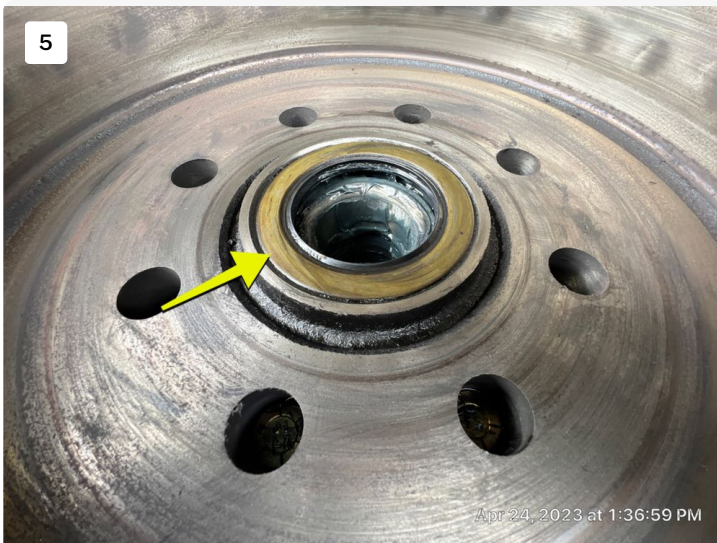
The streetside front wheel seal was installed too far on one side causing the seal to wobble when the hub rotates. The seal was removed and a new seal was installed.

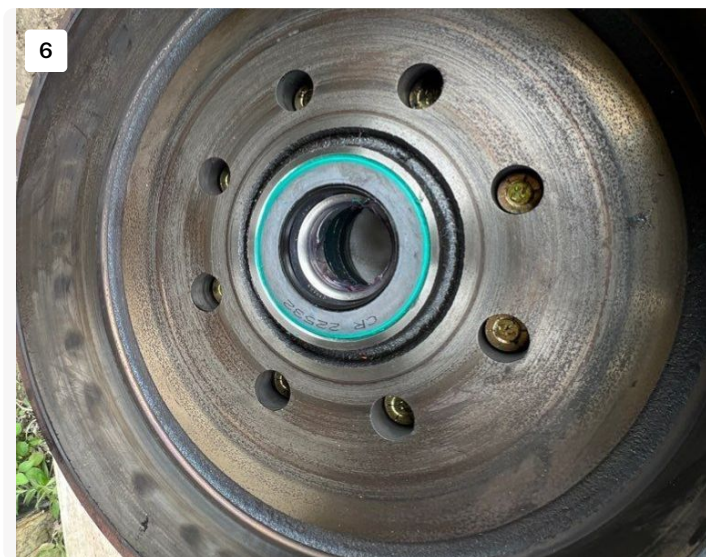
New double lip wheel seal installed.

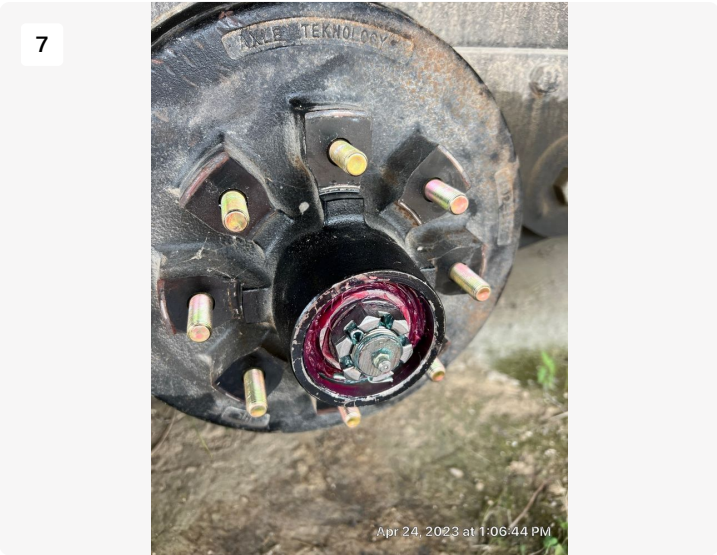
Bearings were torqued to 50 ft lbs.

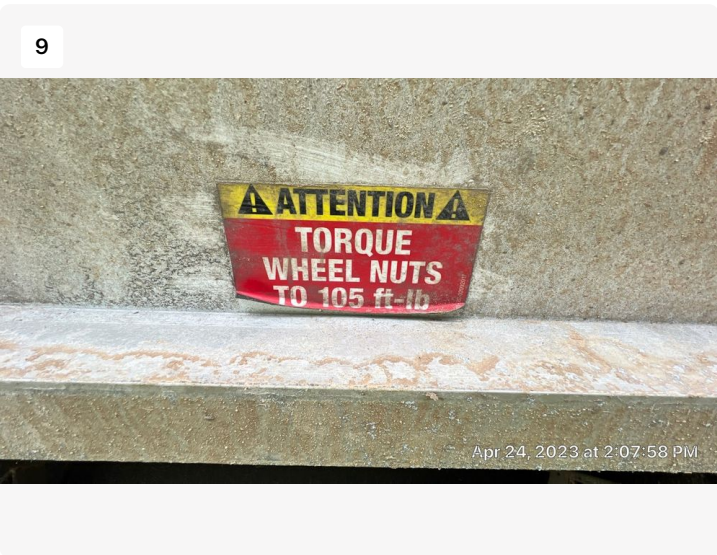
All lug nuts were torqued to 105 ft lbs

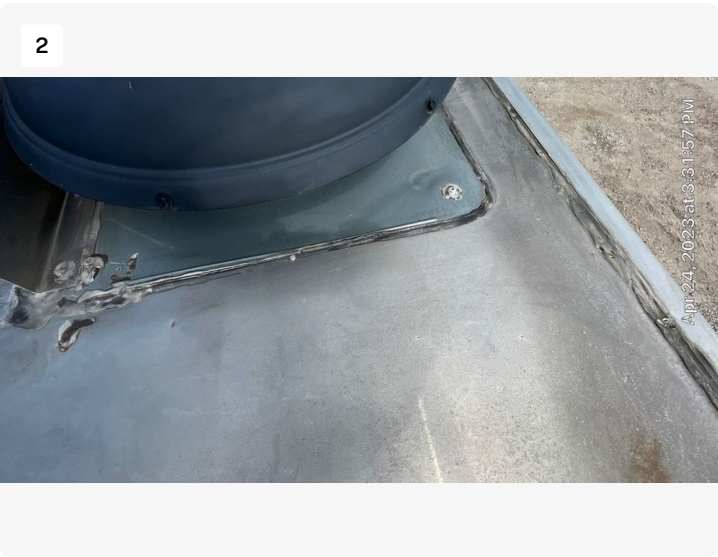
Roof vent sealant is cleaned and prepped for new sealant to be applied.

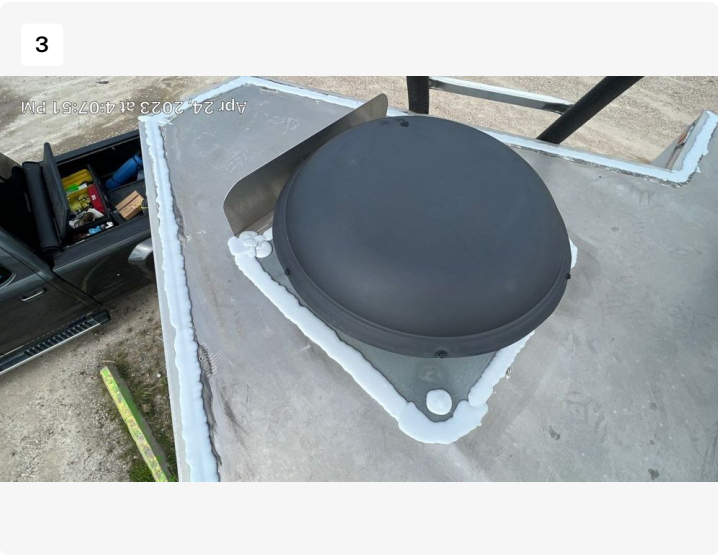
New sealant is applied around the roof vents.

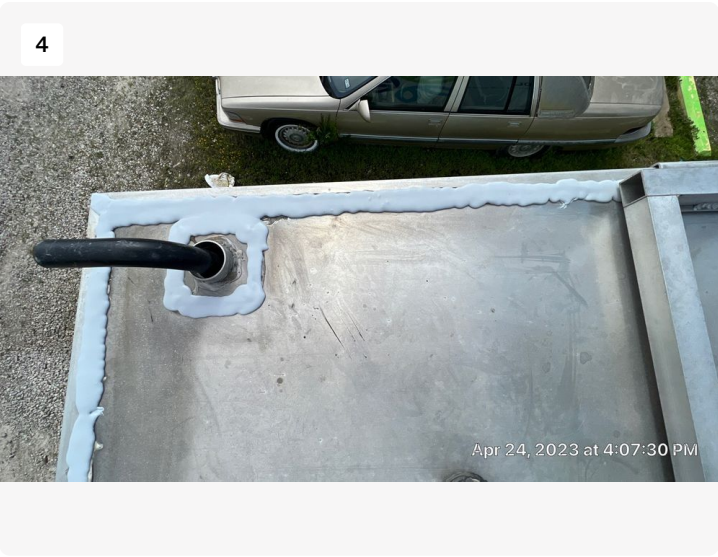
New sealant is applied around the perimeter joints and roof penetrations.

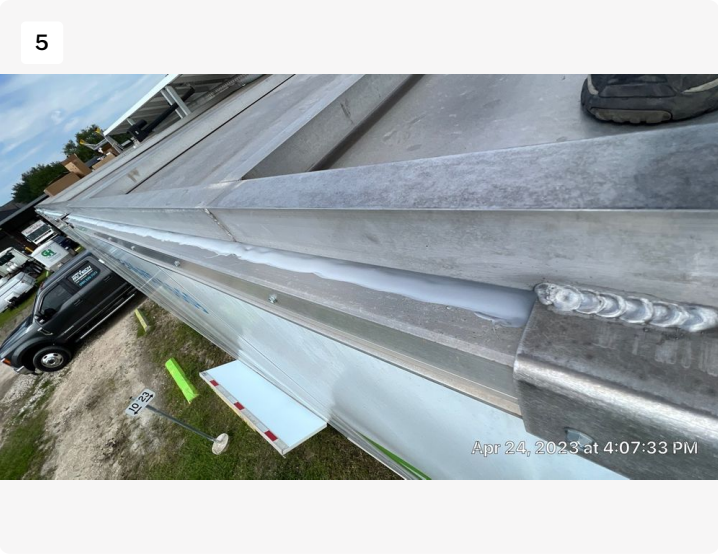
New sealant is applied around the accessible perimeter joints.

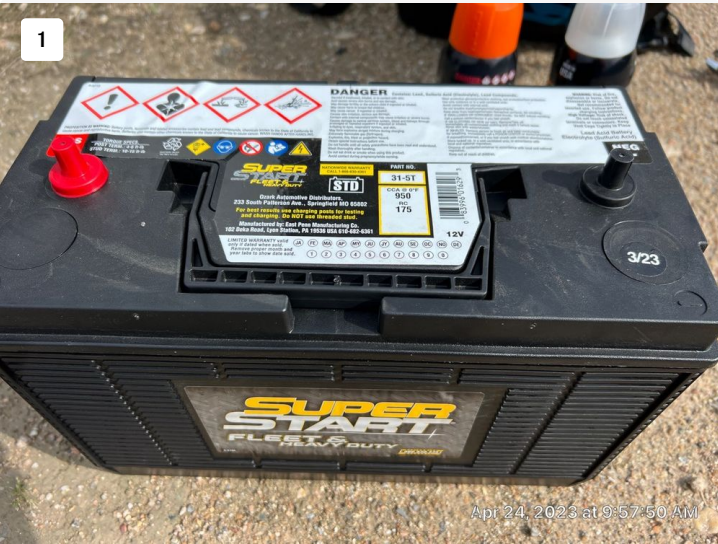
New group 31 battery, 950 CCA rating.

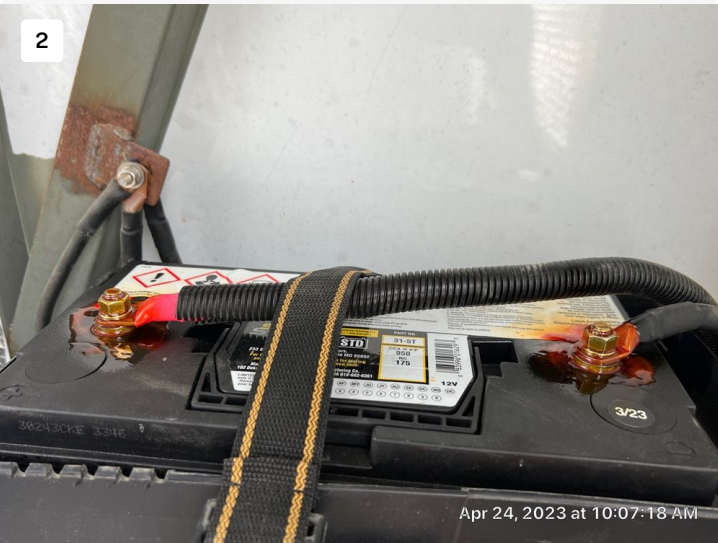
New battery installed with anti corrosion spray applied to the terminals.

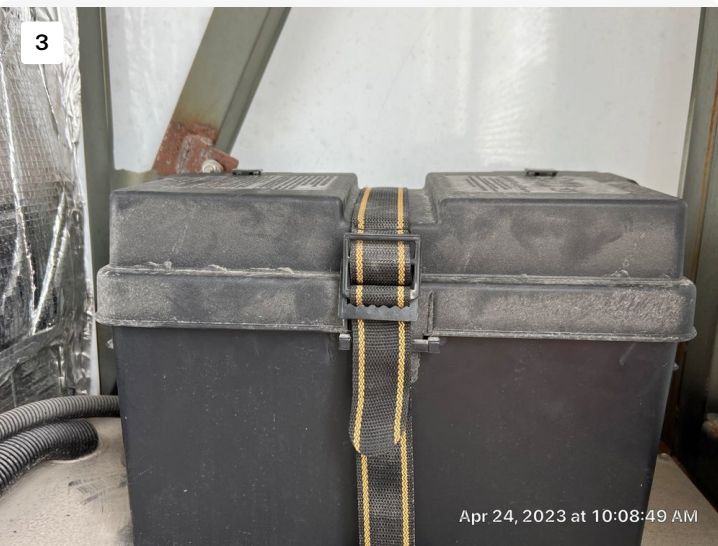
The battery has a battery box with a cover and a strap to secure the battery.

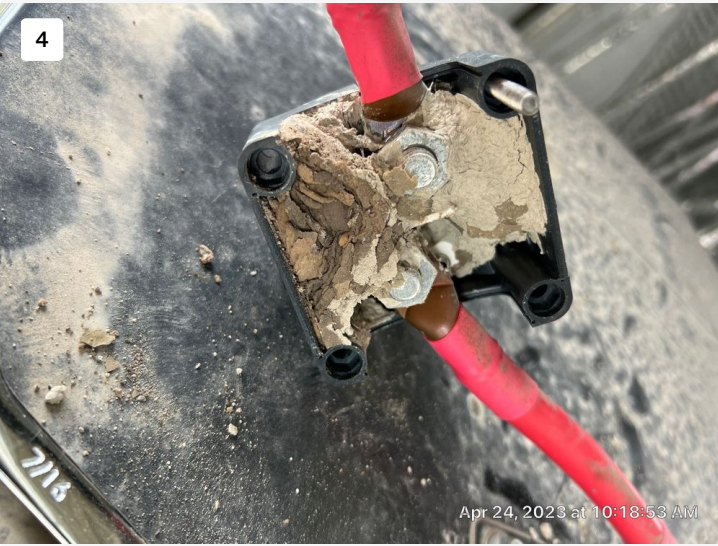
The battery disconnect switch had a mud daubber nest in it.

The battery disconnect switch was cleaned and re-installed.

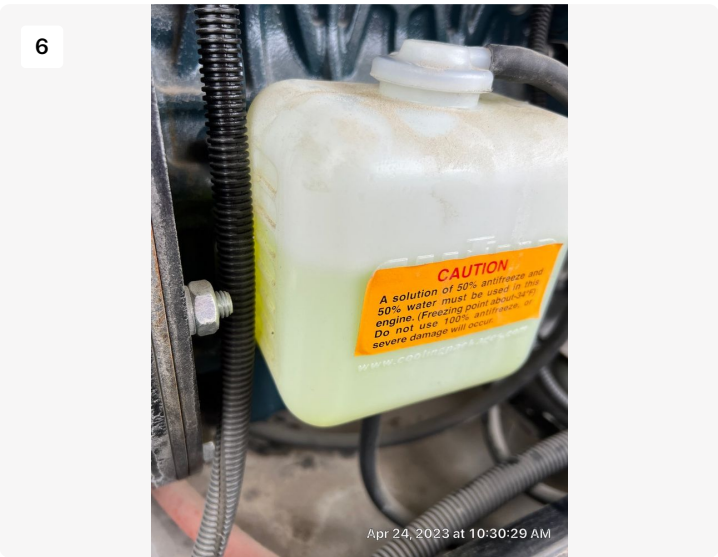
Generator coolant was brought up to the cold fill level.

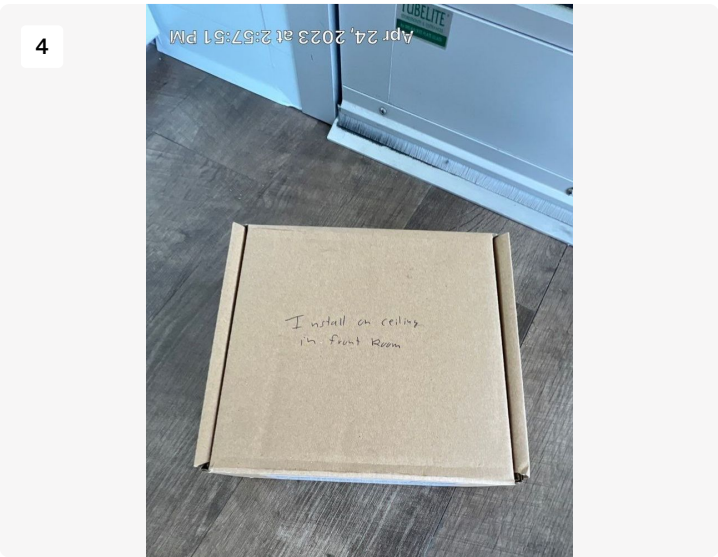
The door is locked for the front room and the smoke alarm is left to be installed once the door is unlocked.

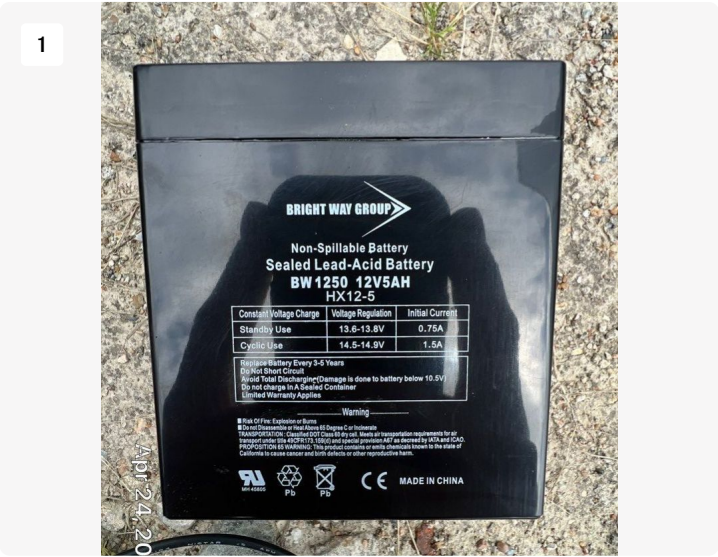
Battery Reference information for to replace the bad battery for the emergency brakes.

Battery:  
BW 1250, 12 Volt, 5 Amp Hour

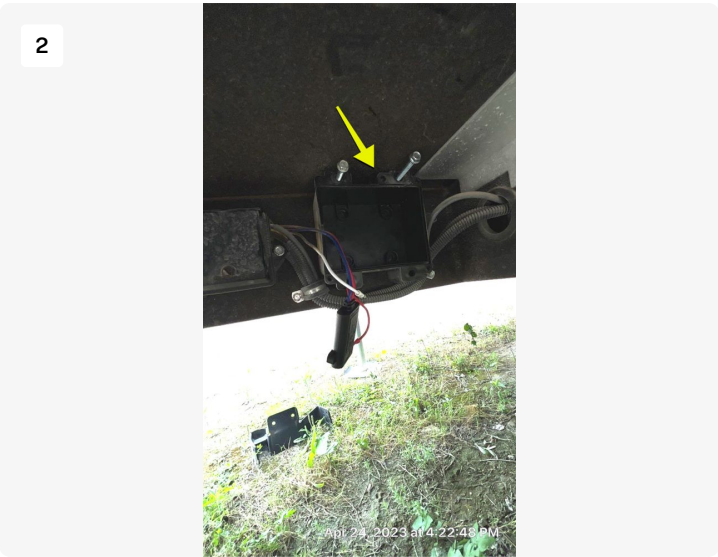
is going to replace the emergency brake battery that is located under the frame near the front of the trailer.
